**SALISBURY CROSSING
HOMEOWNER'S
ASSOCIATION
KERNERSVILLE, NC**

**DATE:
SEPTEMBER 15, 2021**

**RESERVE STUDY
UPDATE**

GILES & FLYTHE
ENGINEERS

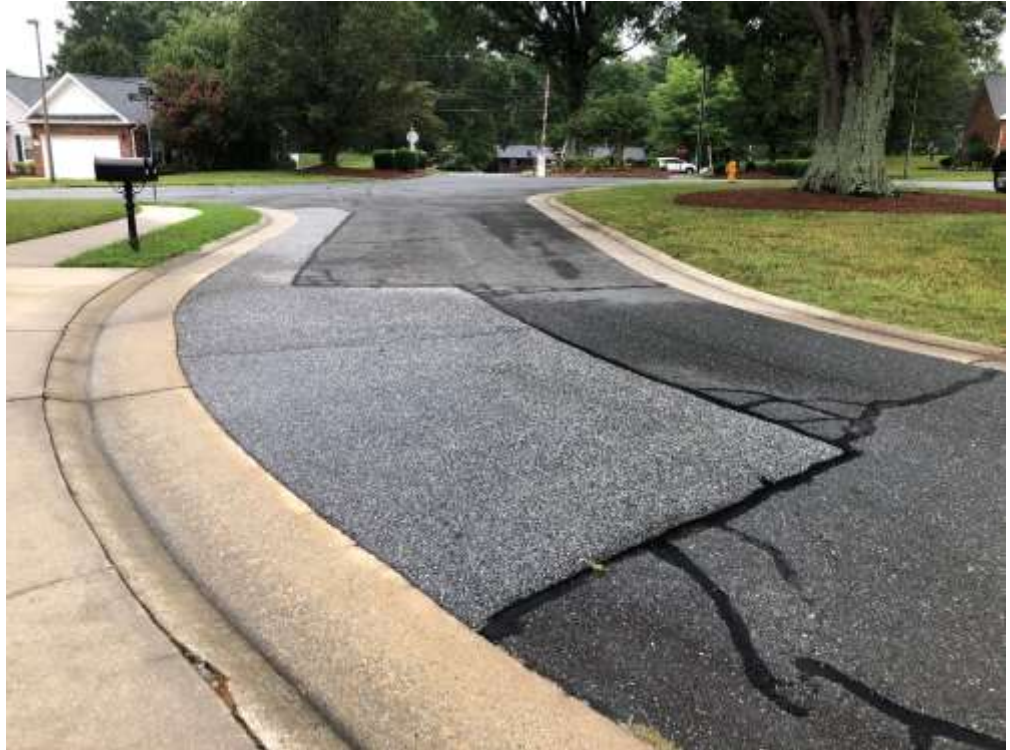
Photo No.
1

Filled cracks and previous repairs along the asphalt private streets.

The roads throughout the community are asphalt paved, are private and maintained by the Association. These streets include Salisbury Crossing Court, Charles Conner Drive, Thomas Ross Lane, Avery Way, John Austin Court, Jennings Park Trail and Peace Rollins Court. The streets have had previous crack repairs and limited sections of asphalt patching. Overall, the pavement structure is in fair condition with noted cracking and sections of alligating or depressions. We have allocated funds for continued crack repairs on a 5-year cycle beginning in 2022.

In addition, we noted numerous sections of fatigue cracking (alligating) developing in the asphalt within the community, which indicates deterioration of base course and subgrade material. Full depth repairs would include saw-cut and removal of sections of pavement, repairing the subgrade and installing 2-4" thick new asphalt paving flush with the existing surface. We have allocated funds for full depth repairs of sections of paving on a 5-year cycle beginning in 2024.

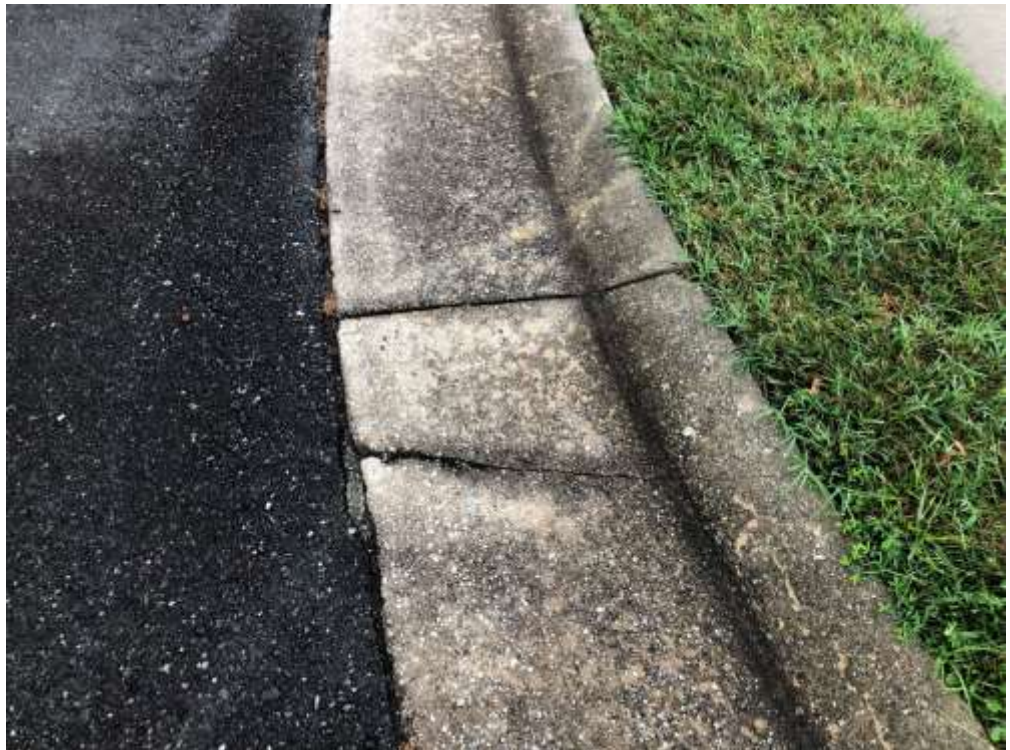
Photo No.
2

Transverse cracks along the concrete valley gutter.

The streets are lined on both sides by 30" concrete valley gutters, which are in generally good condition. Areas of transverse cracking were noted, though no significant vertical displacement was observed. Though concrete curbing and flatwork has an expected useful life greater than the term of this study, sections of replacement will be required. We have assumed approximately 2% of curbing will be replaced every 8 years beginning in 2026.

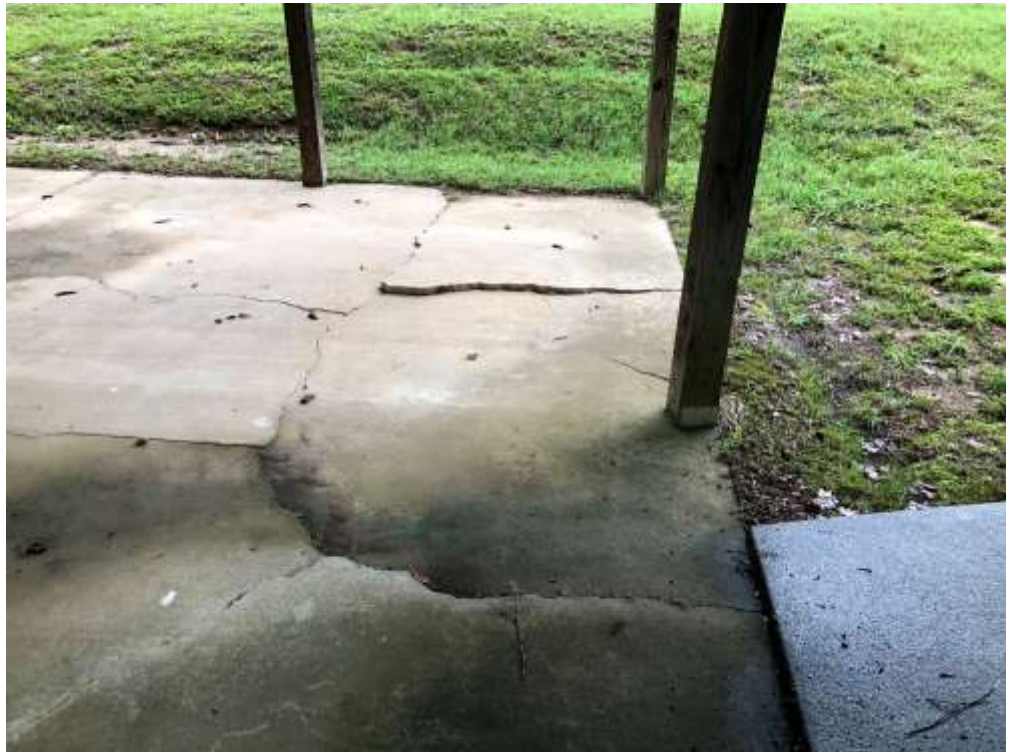
Photo No.
3

Vertical displacement of the concrete flat work at the pavilion.

One side of the street is lined with a 4-foot concrete sidewalk; concrete walkways, stairs, and flatwork is also located at the covered pavilion adjacent to the pond. The sidewalks are in generally good condition with limited cracking, while the flatwork and steps at the pavilion have significant cracks with vertical displacement requiring replacement in the near term. We have included funds to replace approximately 2% of concrete flatwork every 8 years beginning in 2026.

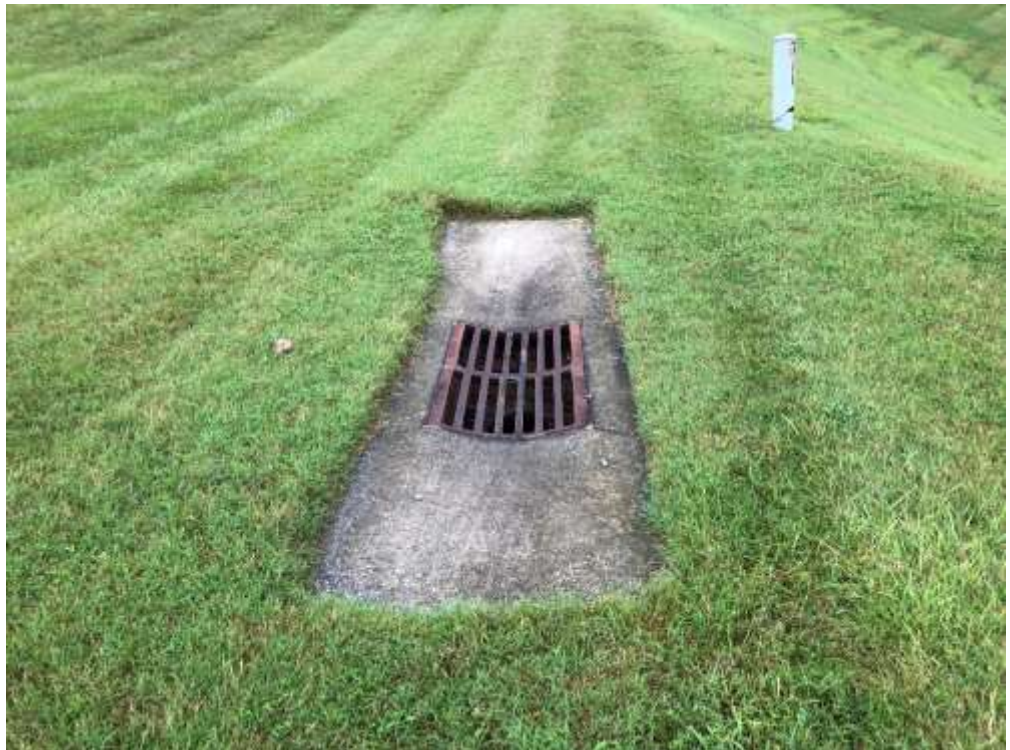
Photo No.
4

Drainage inlet within landscaped areas.

The common drainage systems generally appeared to be in good condition with no significant areas of erosion observed. It is likely that erosion concerns and other drainage concerns will develop over time and require repair. We have allocated funds to periodically inspect and repair the drainage systems on a 5-year cycle beginning in 2023. Repairs will likely include retrenching of swales to improve flow, inspection/maintenance of underground systems, installation and repair of rip rap or turf reinforcement at outlets and on steep slopes, installing French drains or other types of subsurface drainage systems. These types of repairs can be moderate (re-trenching swales, flushing pipes), to very expensive (new underground pipe systems). We have included a moderate budget to help cover these costs.

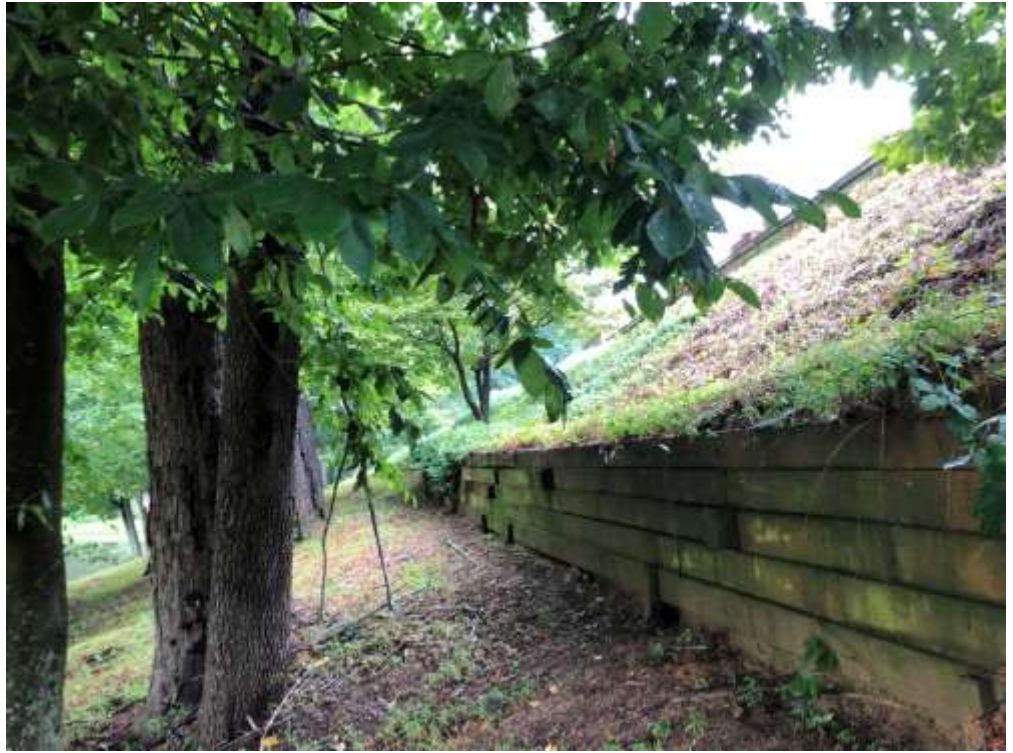
Photo No.
5

Timber retaining walls are located adjacent to several townhomes and are in fair to poor condition. Many of the walls were originally constructed improperly, with missing or inadequate “deadmen” to support the walls. Leaning and bulging walls were noted, particularly near the pond. This wall section should be repaired in the near term. Timber walls can typically provide approximately 15 years of useful life prior to replacement. In lieu of timber walls, we have provided funds for replacement with segmental block retaining walls, which should provide a much longer useful life. Due to the varying conditions, we have assumed approximately 1/3 will be replaced every 6 years beginning in 2022.

Timber retaining wall behind Units 547 and 551 with areas of bulging.

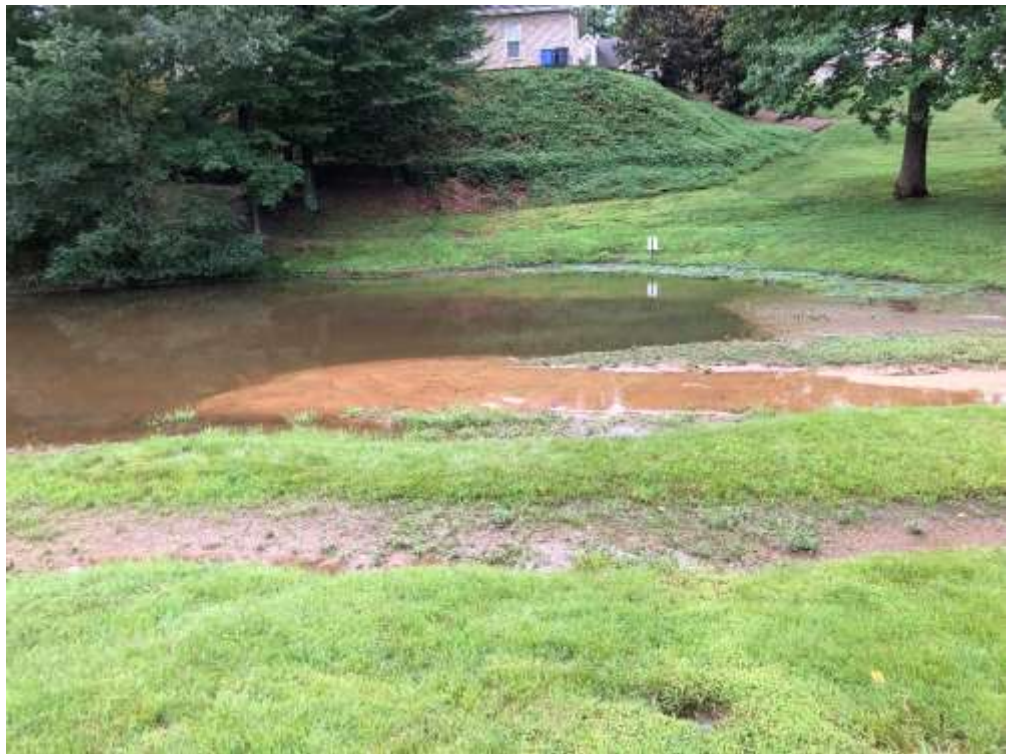
Photo No.
6

The drainage systems discharge stormwater through a stormwater retention device located along the east of the property. The stormwater retention device was visible and appeared to be a wet pond. The pond generally appeared to be in fair condition with areas of significant sediment deposits. In areas of sediment deposits the water level appeared to be approximately 3-6 inches deep, which results in poor water quality. In order for the ponds to function properly, they will require regular cleaning and maintenance. These maintenance costs including nuisance control, debris and litter removal, inlet and outlet maintenance and inspections and are assumed to be taken from the general operating budget. We recommend the association hire a stormwater pond maintenance company to complete regular inspections and maintenance activities each year. The HOA should ensure that the pond conforms to all applicable regulations at all times. In addition to significant areas of sediment accumulation resulting in poor water quality, the outlet riser structure appears to be leaning and in need of repair. We have allocated funds on a 15-year cycle beginning in 2022 for major repairs to the pond including dredging areas of significant sediment accumulation, repairing the outlet structure, cleaning out stormwater piping and other repairs. We have assumed sediment would be disposed of offsite.

Sediment deposit within the stormwater retention device (pond).

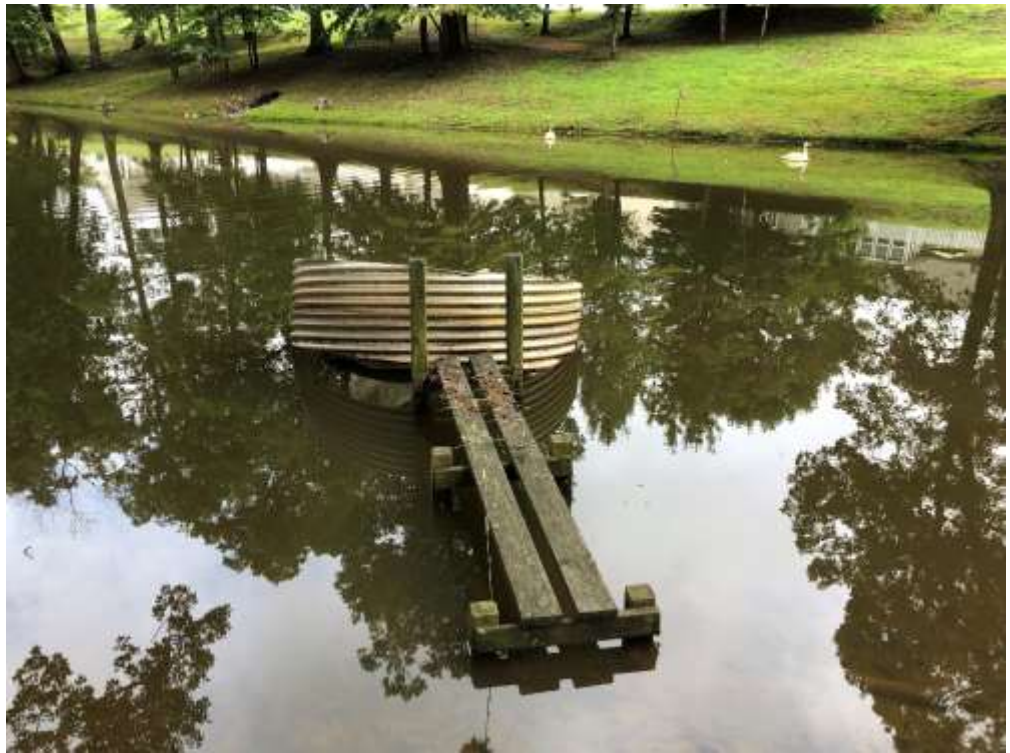
Photo No.
7

Leaning metal riser structure within the pond.

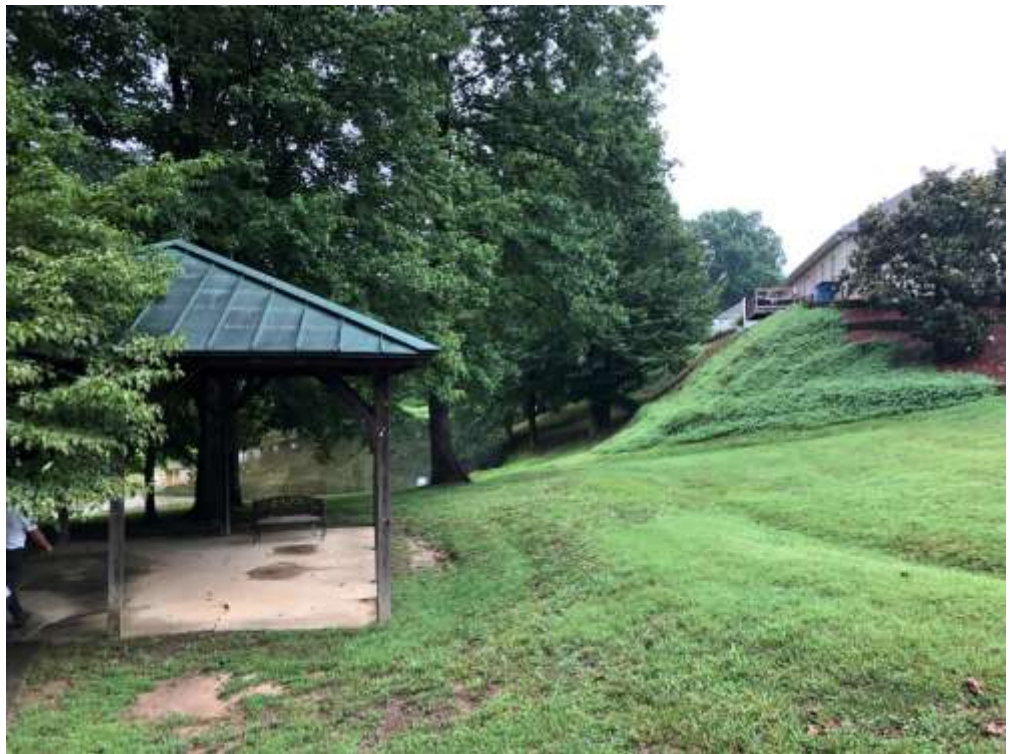
Photo No.
8

Metal roof and timber structure pavilion.

The pavilion adjacent to the pond is wood-framed with painted metal roof panels. We have provided funds to make minor repairs every 8 years beginning in 2030, including replacing structural members and coating the roof surface.

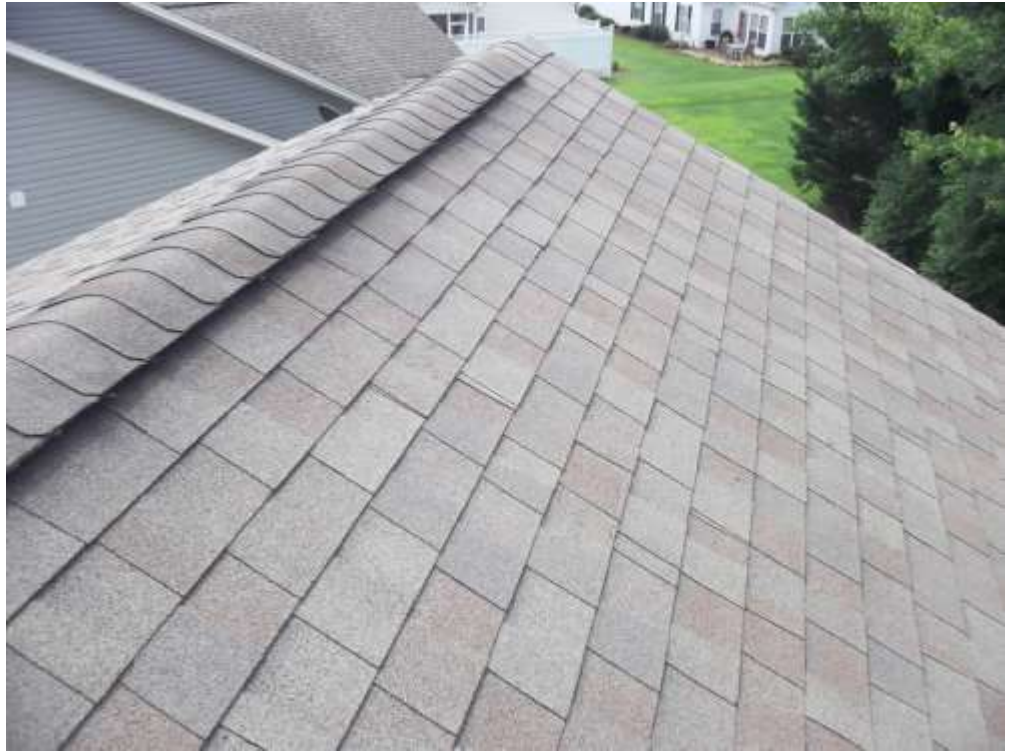
Photo No.
9

Asphaltic architectural grade shingles on the roof of Units 400, 402, and 404 Peace Rollins Court.

We strongly recommend that any re-roofing project closely follow procedures outlined by the National Roofing Contractors Association's *Roofing and Waterproofing Manual*, Fourth Edition. A re-roofing sequence should include removal of the existing roofing material, replacement of any inadequate roof sheathing, replacement of any damaged flashing, and replacement of drip edge components. Assuming minor repairs are completed in the interim, we estimate the remaining life of the shingles, on the remaining buildings, to be approximately 2 to 8-years based on our observations of the above-mentioned sample roofs. Re-roofing of the existing remaining buildings is assumed to be completed in 2 phases, projected for 2023 and continuing in 2026. We have assumed half (20 units) of the remaining units will be re-roofed in each phase.

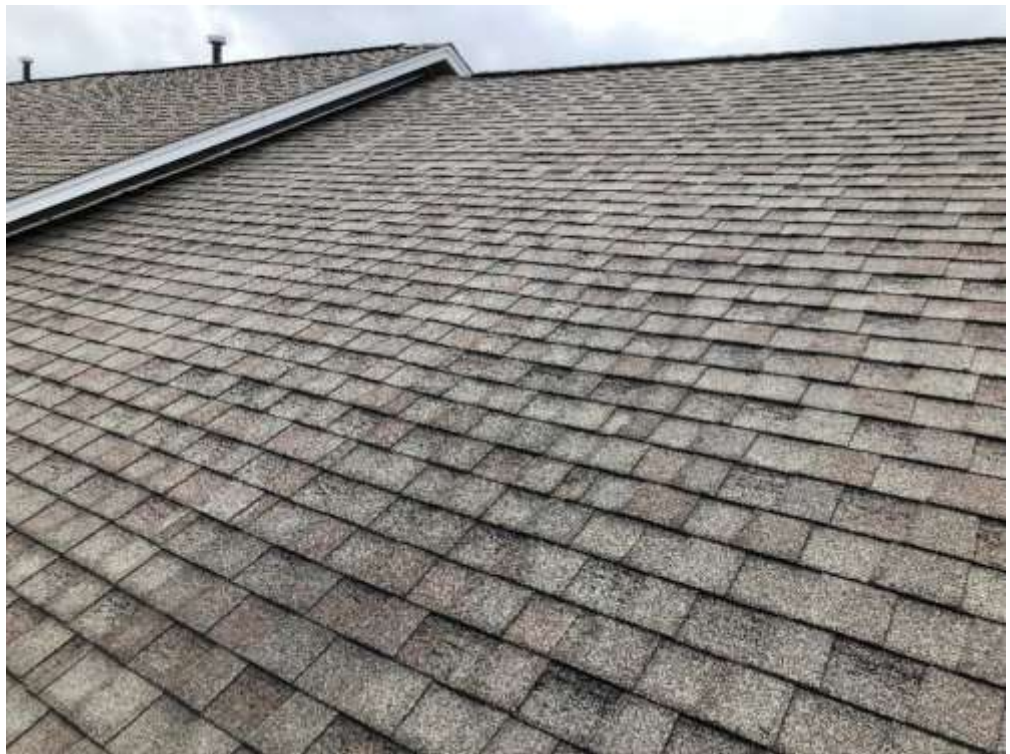
Photo No.
10

Asphaltic architectural grade shingles on the roof of Units 406 and 408 Peace Rollins Court.

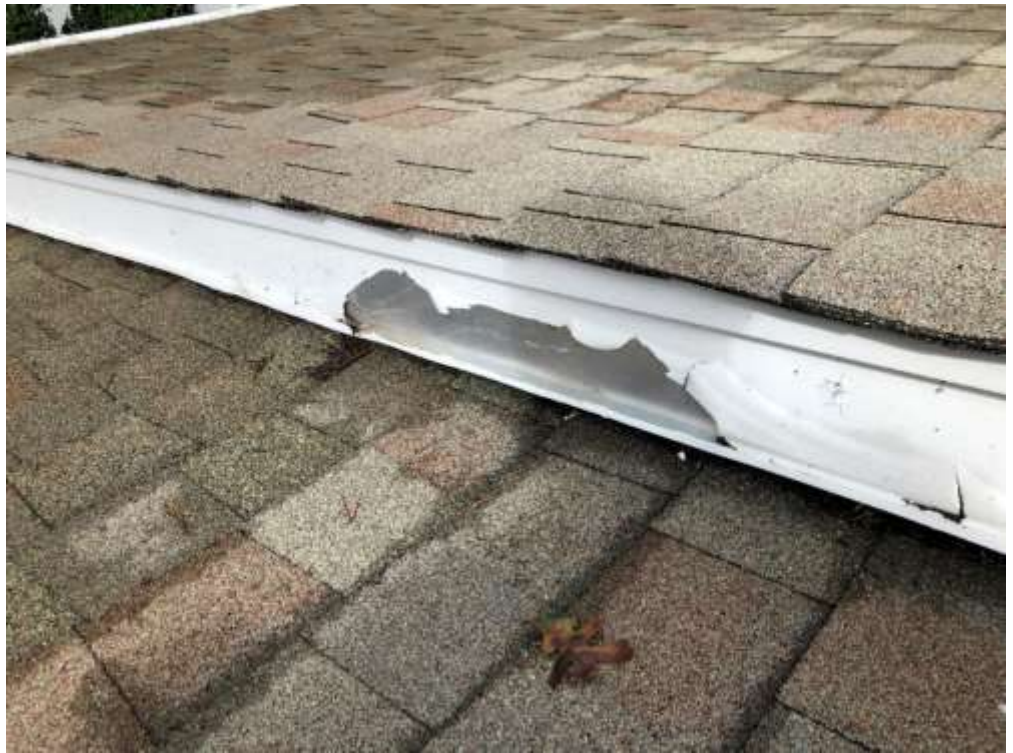
Photo No.
11

Deteriorated paint at trim elements along the roof.
